Site Highlights

Remediation of Residential Properties

Montclair/West Orange and Glen Ridge Radium Sites
Montclair Township, West Orange Township and Glen Ridge
Borough, Essex County

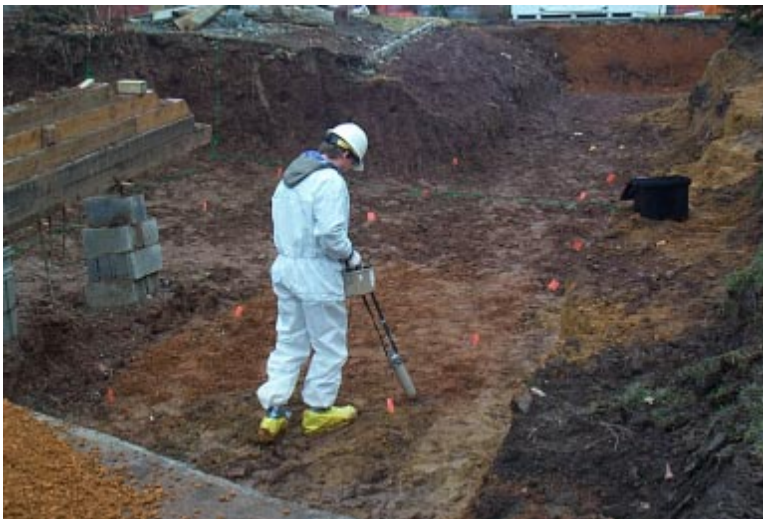
A USEPA contractor takes gamma radiation measurements after radium-tainted soil was removed from a property in Montclair.

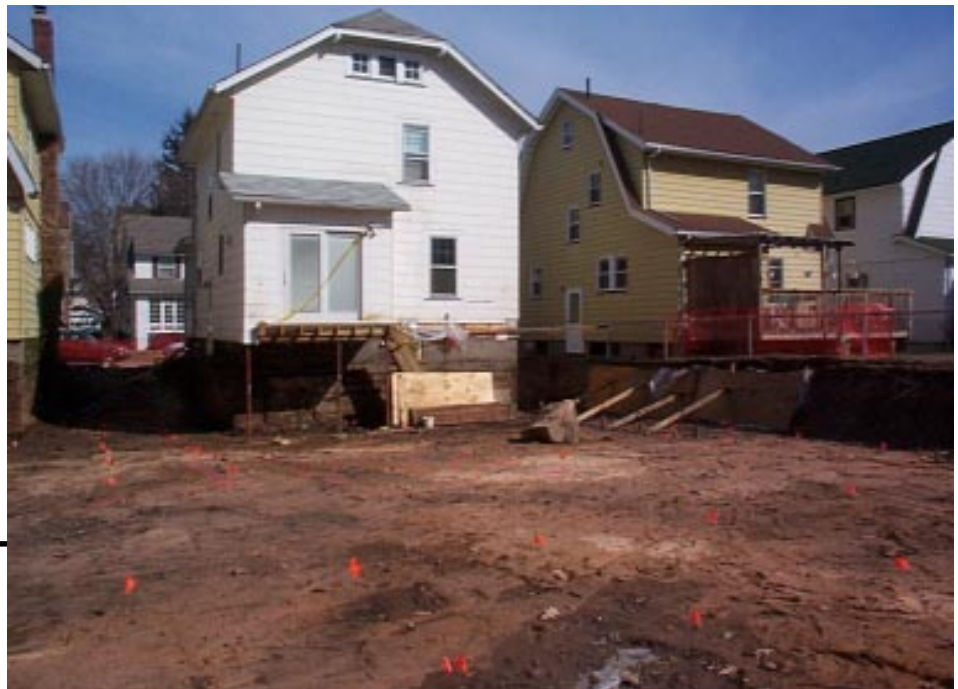
The entire backyard of this property in Montclair was excavated during cleanup actions in 1998 to address radium-tainted soil.

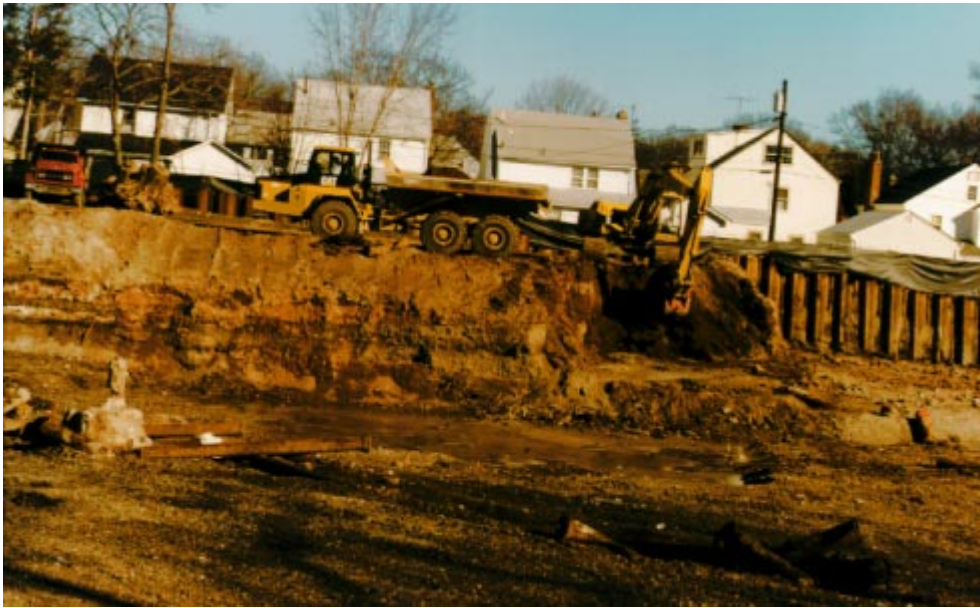
An excavator removes radium-tainted soil from Barrows Field in Glen Ridge. Layers of radioactive tailings can be seen in the fill used to create the park's landscape decades ago.

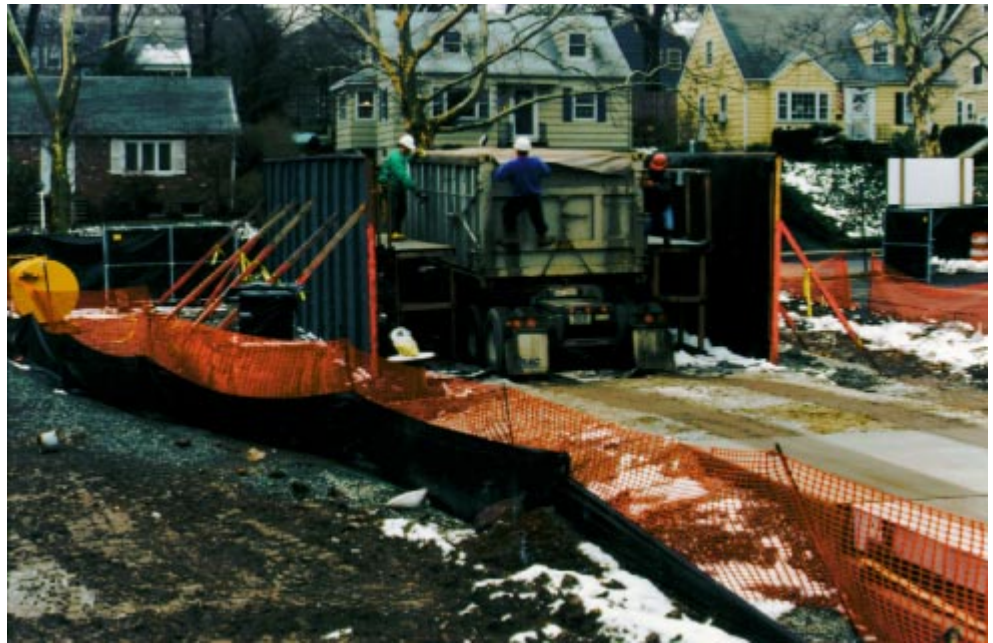
A truck's tarp is fastened before radium-tainted soil excavated from Barrows Field is transported to a rail yard in Irvington. The material is taken by train to a site in Utah for permanent disposal.

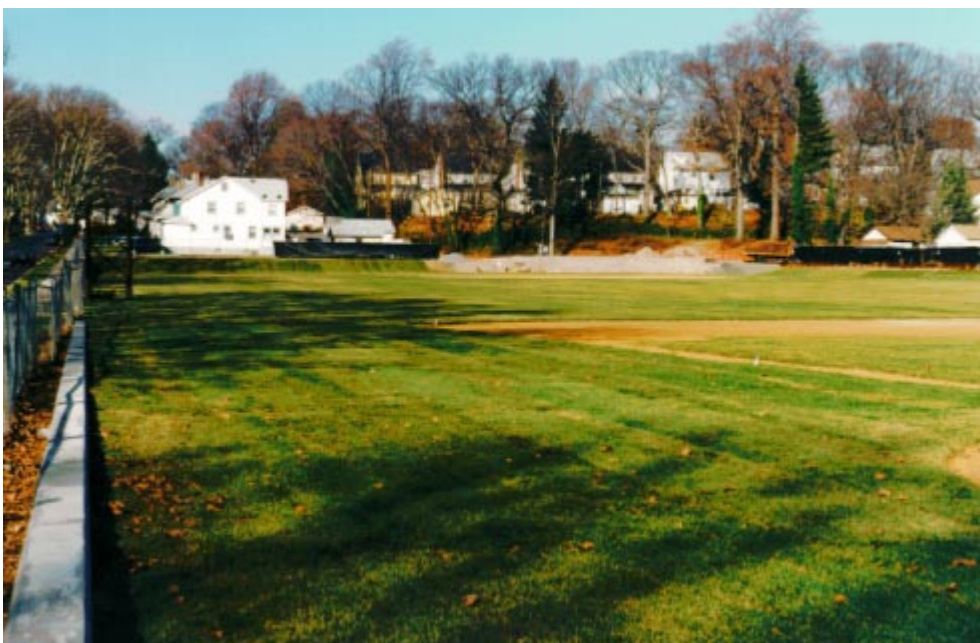
Barrows Field in December 1998 with new sod installed and landscaping almost complete after all radium-tainted soil had been removed.

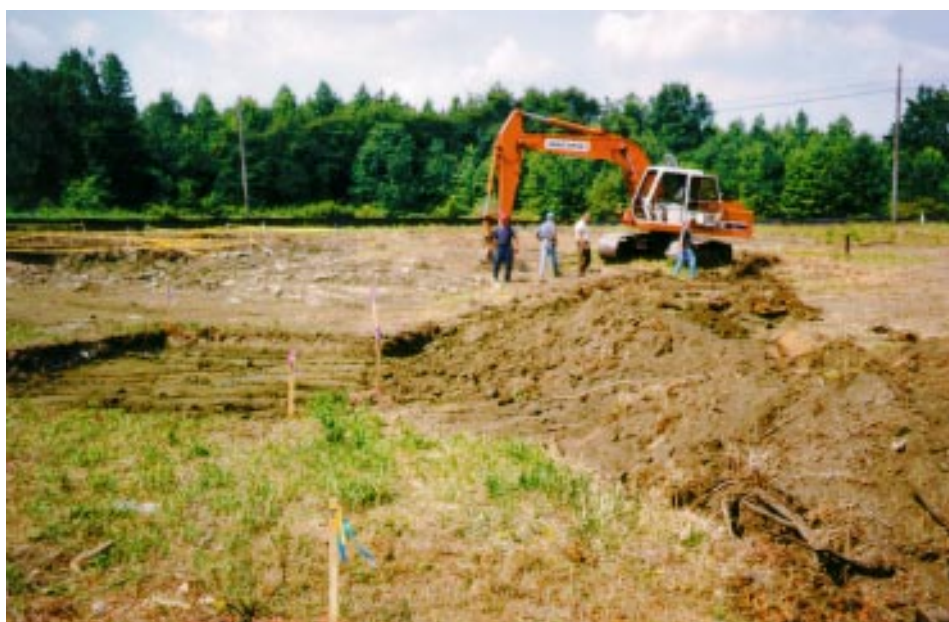
Remediation of shallow soil contamination in progress.

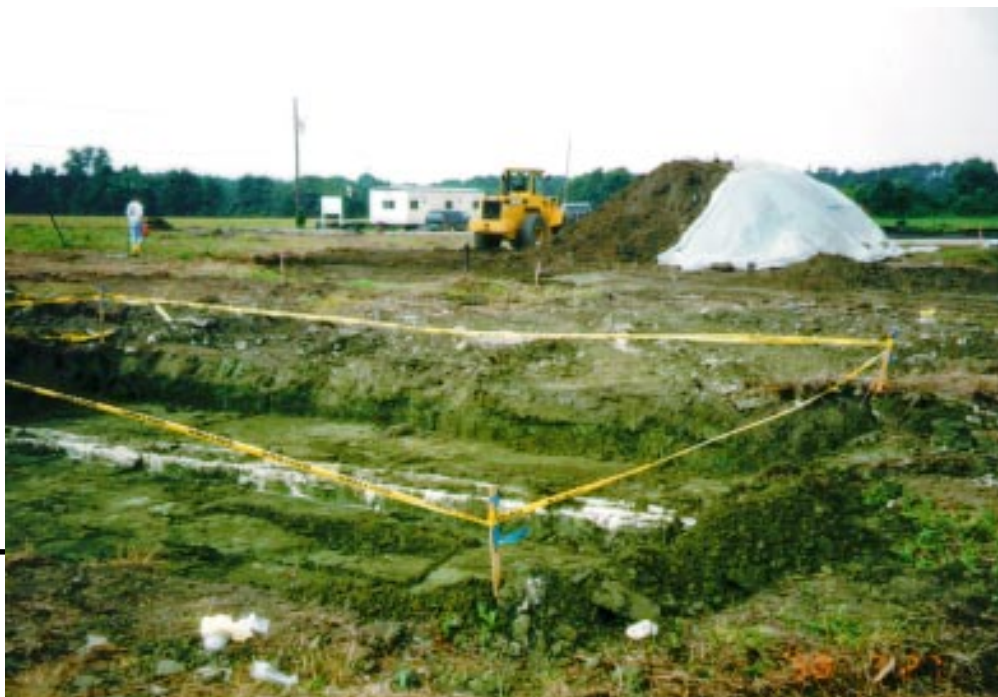
A completed excavation is visible in the foreground. In the background, contaminated soil is temporarily staged on site prior to disposal at an off-site facility.

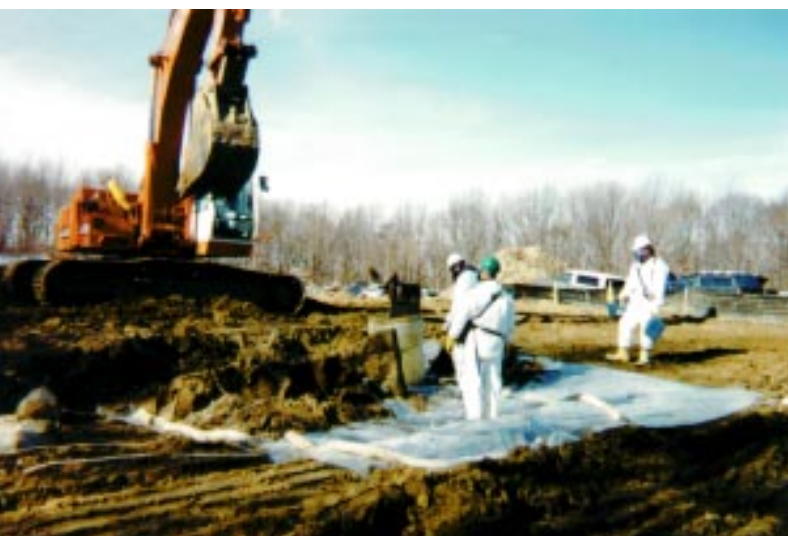
Top left: The excavated drums are temporarily staged on a tarp.

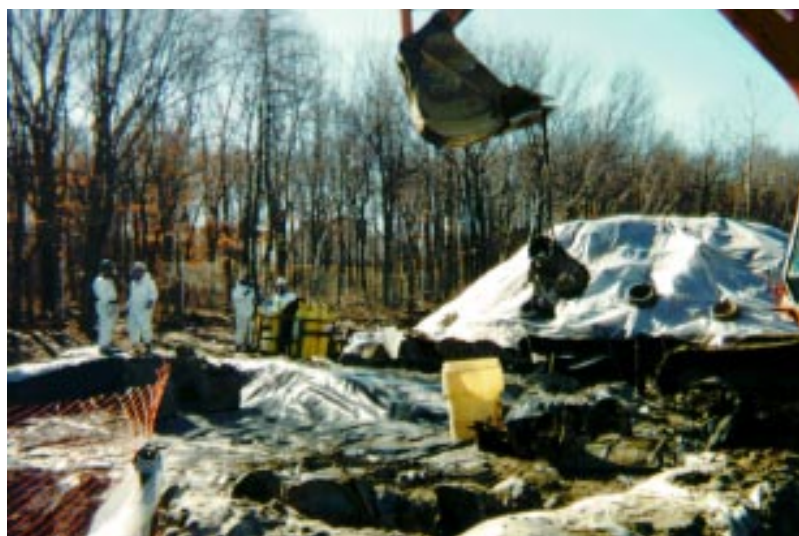
Top right: A backhoe is used to place deteriorating drums into an overpack container.

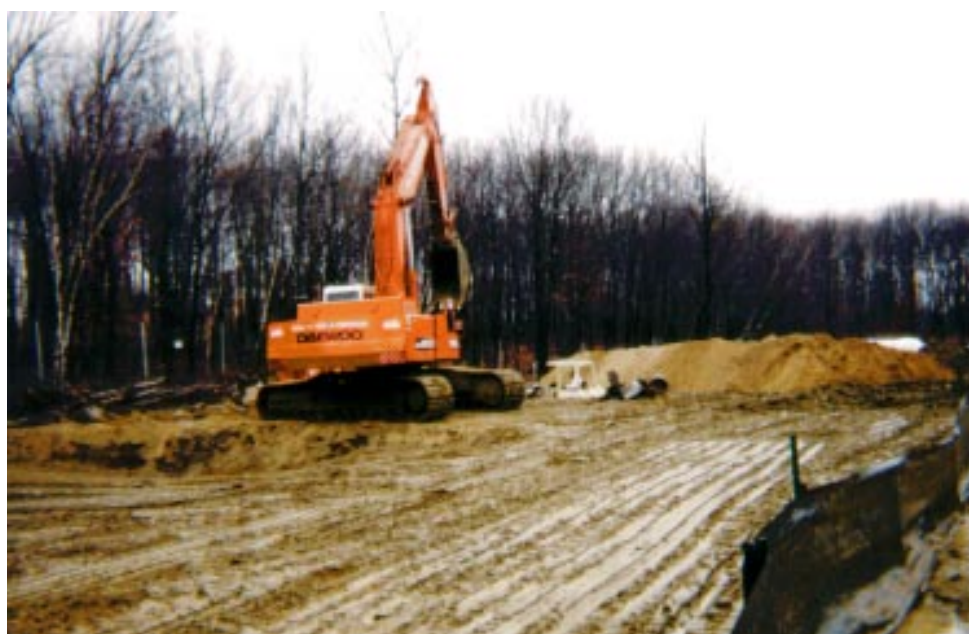
Bottom: The site after the excavation was backfilled and regraded.

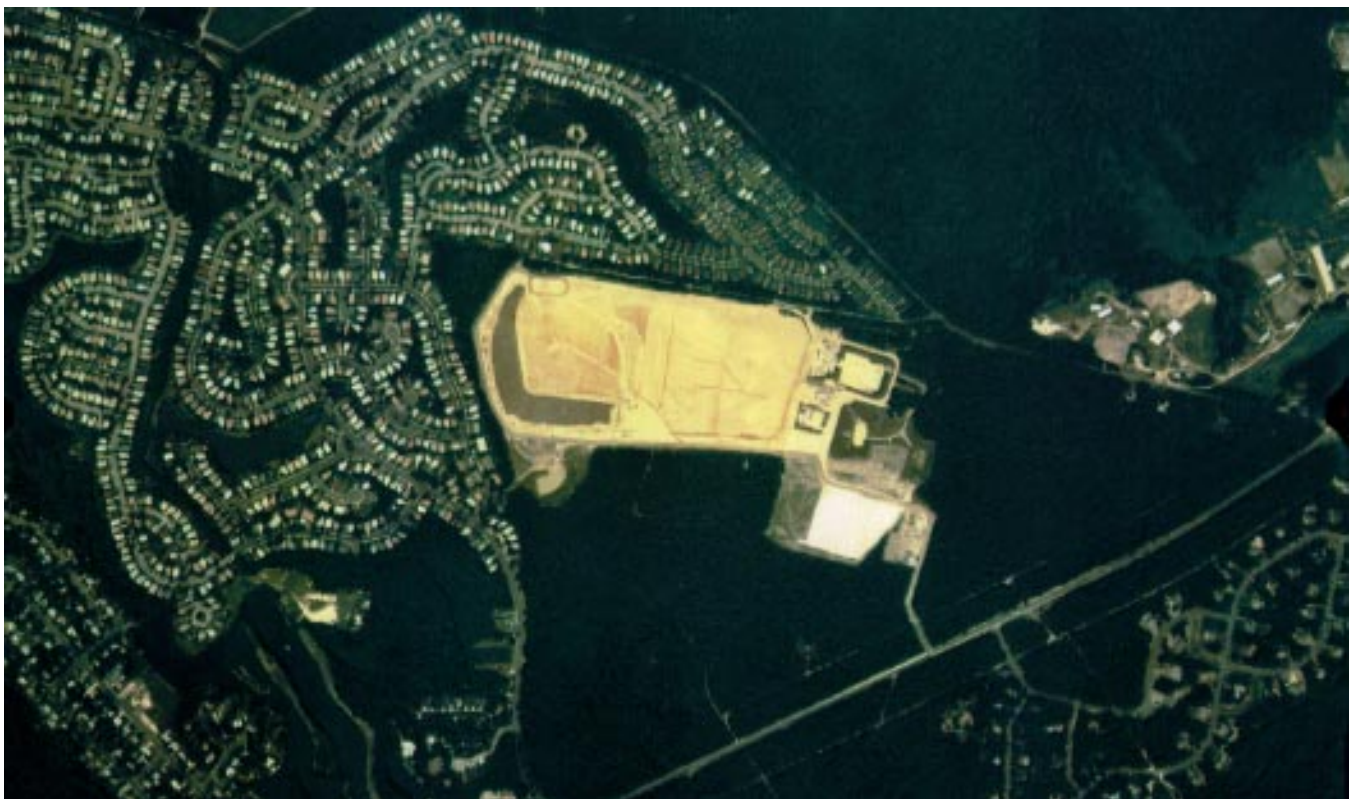
An aerial view of the BEMS/Big Hill Landfill as construction activities are underway.

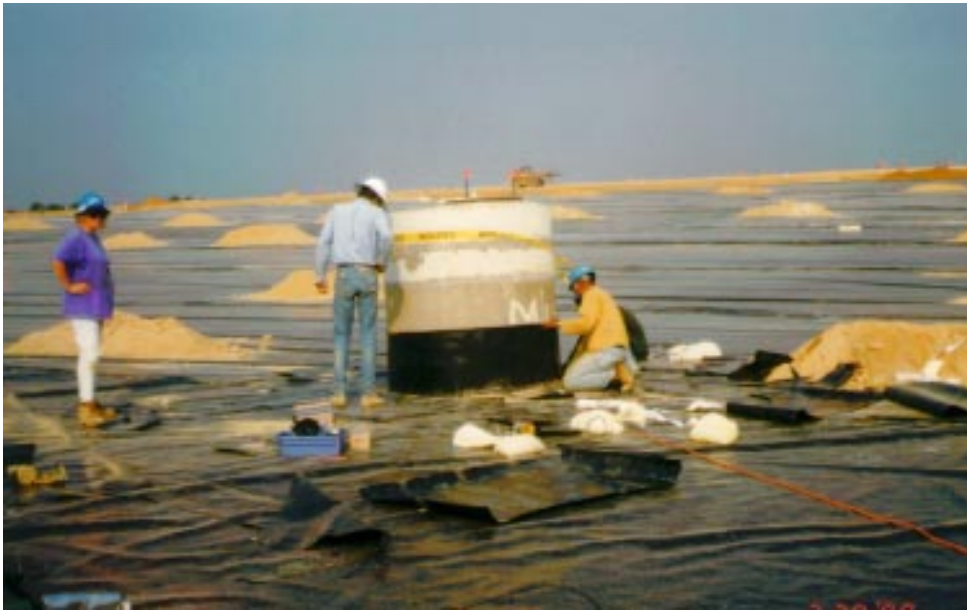
Workers place a "boot" around the base of a methane gas extraction well in an area where the impermeable liner has been installed. This will help ensure that precipitation does not infiltrate the landfill and generate leachate.

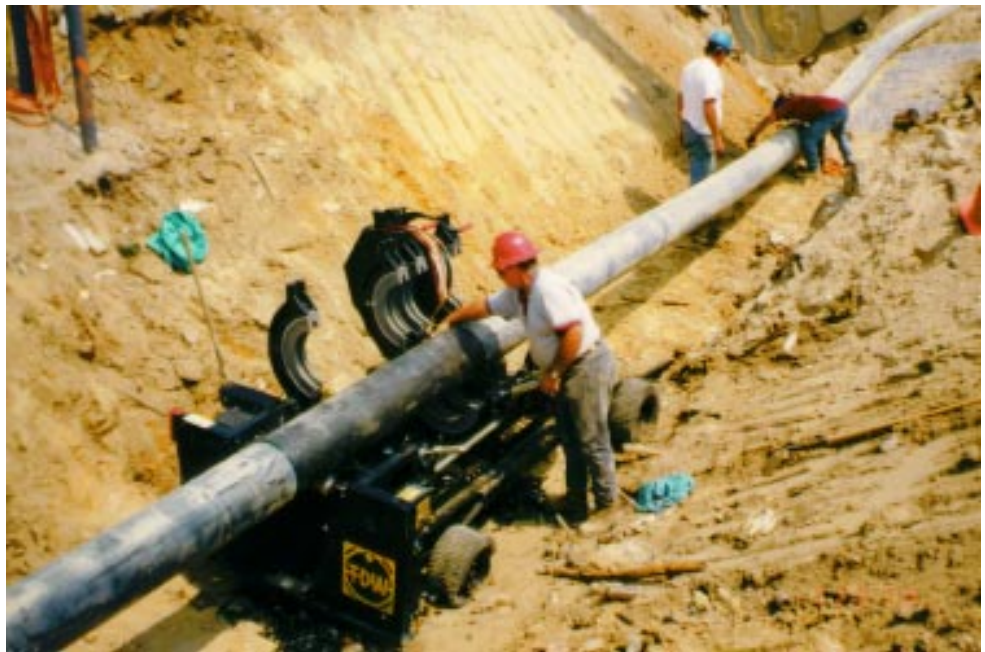
Two methane gas extraction pipe lines are fused together.

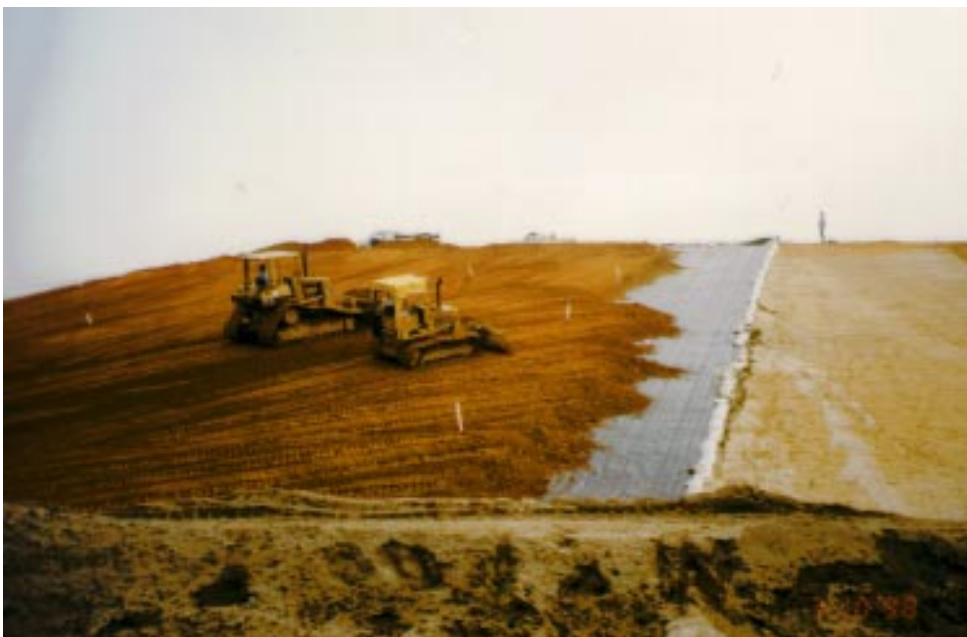
The first layer of soil is placed over the impermeable liner. A final layer of topsoil will be placed on top of the landfill and the site vegetated to prevent erosion.

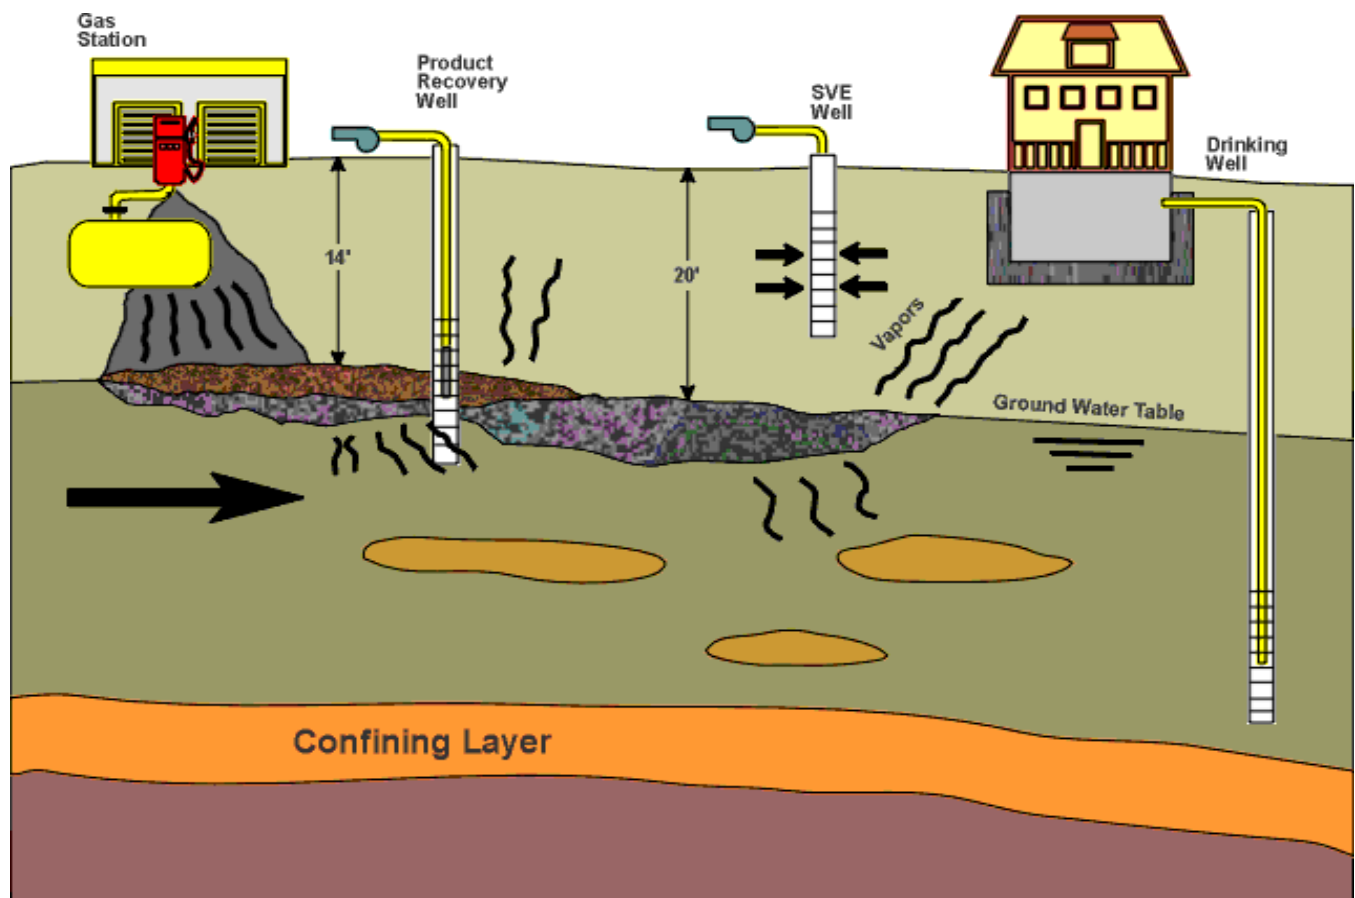
The diagram below shows how organic compounds volatilizing from a layer of floating gasoline product can cause hazardous vapors to accumulate in nearby residences. A soil vapor extraction system intercepts the vapors before they can reach the basements.

area with an asphalt cap to prevent the infiltration of rainwater. Remedial work has been underway at this site since 1997 to address gasoline product that is floating on the water table, which has caused hazardous vapors to occasionally build up in the basements of adjacent residences.

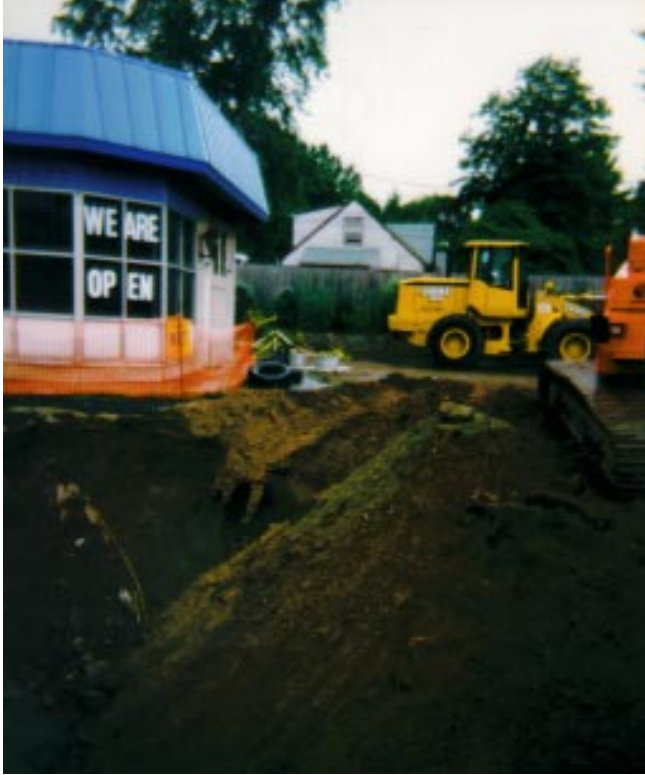
Gasoline-contaminated soil in the process of being excavated.

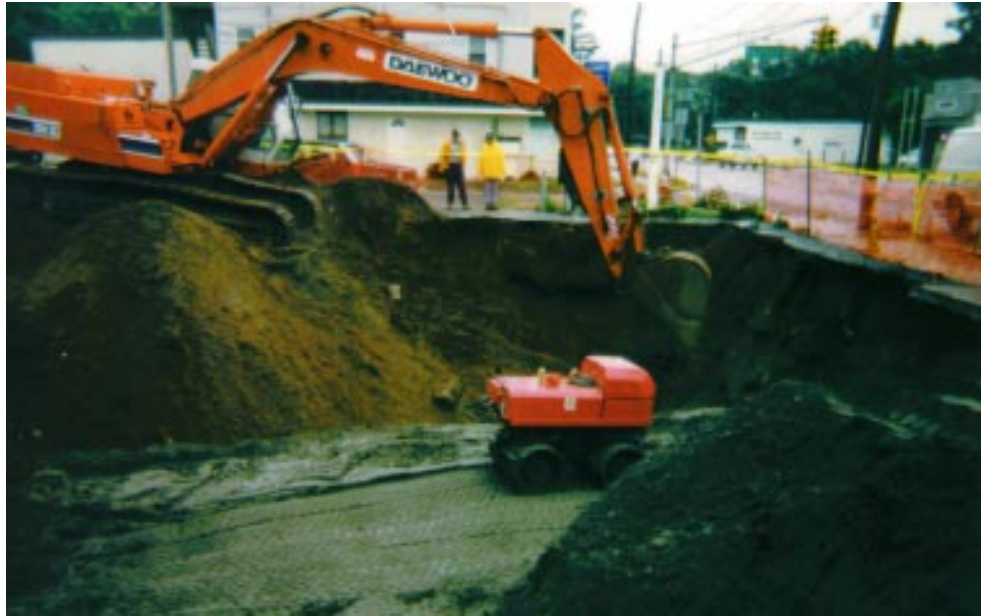
The device in the foreground is compacting the clean backfilled soil.

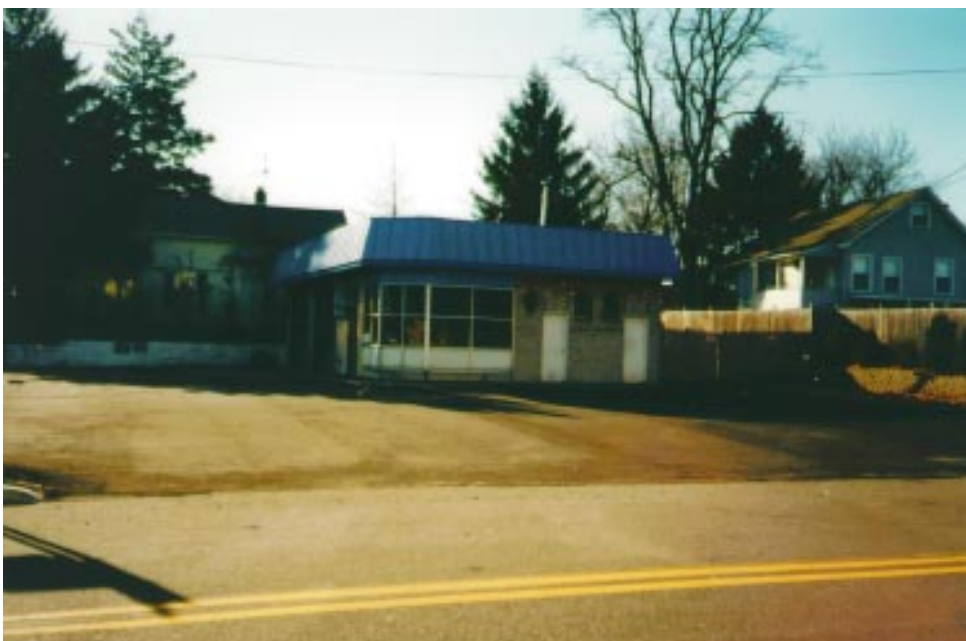
The site after the soil remediation was completed. The soil vapor extraction unit and the free-product recovery system are located in the fenced area between the garage and the residences.

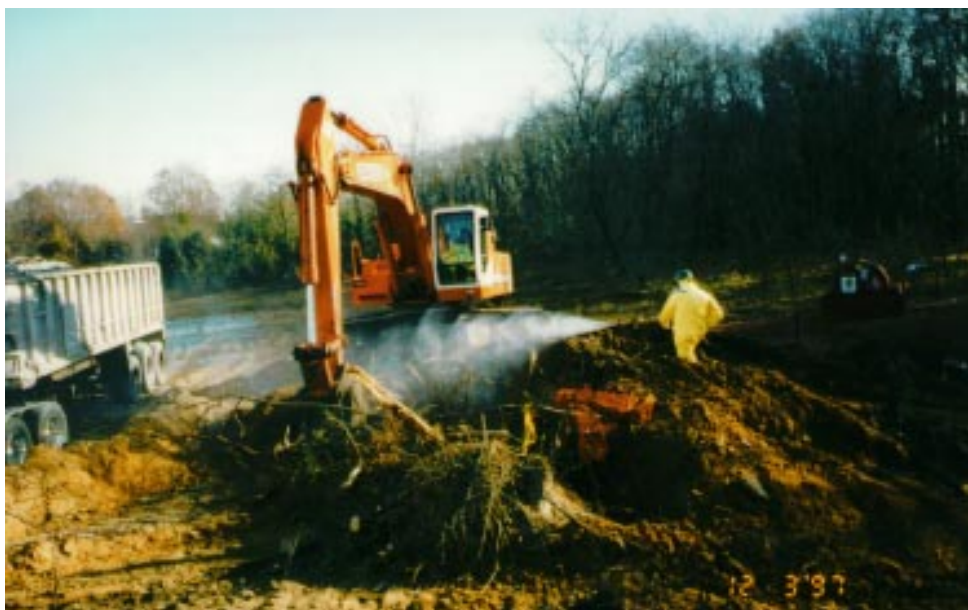
The former sand-mold disposal area is grubbed in preparation for remedial activities.

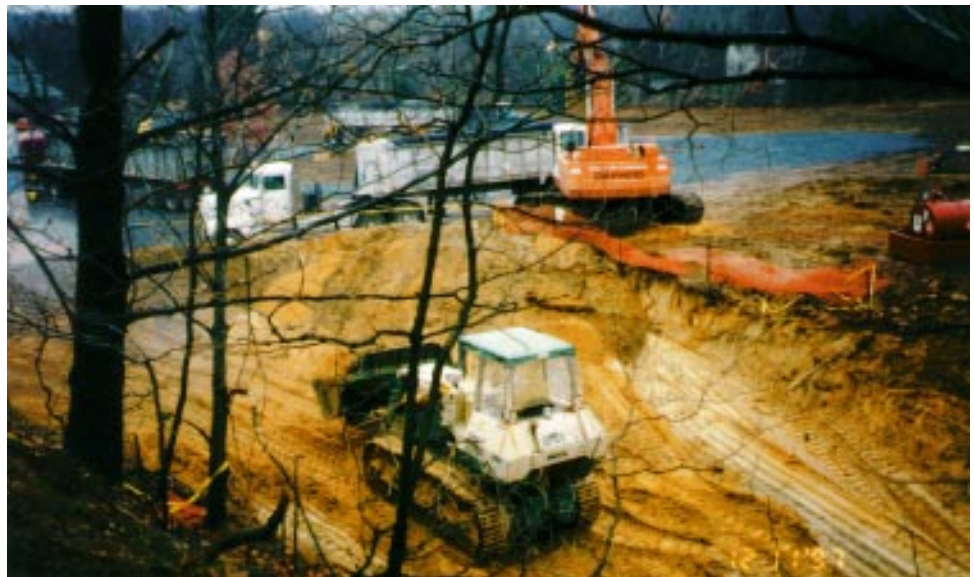
Excavating the lead-contaminated soil.
